BEST PRACTICE 3

- **Brief outline of the asbestos related topic:**
 - **Activity:** Asbestos removal in power station
 - **Place:** municipalities of San Adrián de Besós and Badalona (Barcelona)
 - **Date:** 2012-2013
- **Background:** The owner, Endesa, decided the demolition and dismantling of the old power station located in Besós, built in the 70s and whose activity ceased in 2011.
- **Description:** The works were executed by the specialized company Demoliciones y Reciclados, and consisted basically of two phases; Phase 1 consisted of an inventory of materials which contained asbestos and work planning, and phase 2 was the removal of materials distinguishing non-friable and friable asbestos.

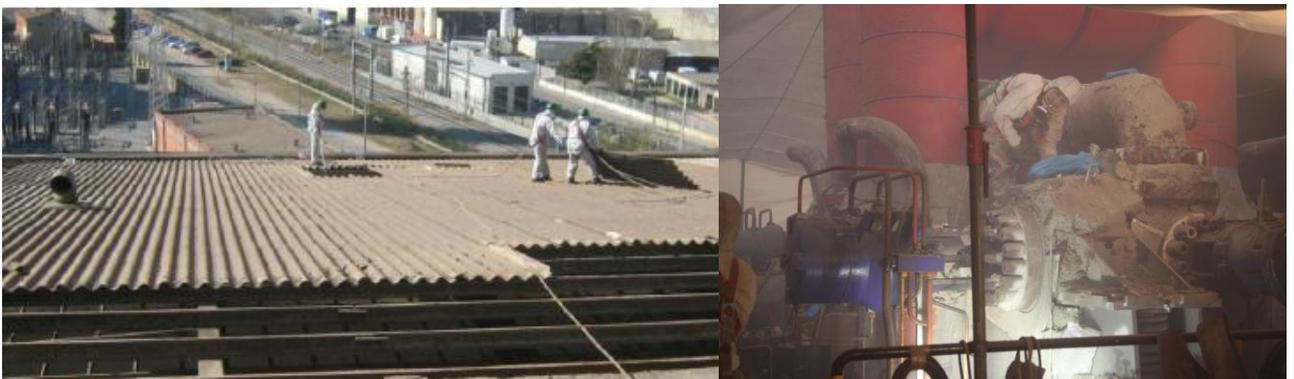
- **Pictures**

The presence of non-friable asbestos was detected: asbestos-cement roof, walls and tanks; asbestos-cardboard in joints without damage; vinyl-asbestos floor. Friable asbestos was also detected in insulation materials of hot spots related to the process of electricity generation (boiler, turbine, connections); cords or damaged asbestos joints; even stockpiles of asbestos containing materials were found.

For the removal of friable asbestos materials, bubbles in depression were installed (plastic structures confining the workspace), whose dimensions were calculated through innovative mathematical methods. Also an amalgamating liquid was injected onto friable materials to avoid the generation of fibres during removal.

For decontamination of workers, modules with 3 and 5 bodies were used. Asbestos waste were carefully packaged, labelled and delivered to an authorized waste company.
